1150 Morrison Drive, Suite 410
Ottawa, ON, K2H 8S9
T.613.828.7800 F.613.828.2600
Project No. 2082444A

Energy Audit

Westmeath Recreation Centre

119 Synton Street, Westmeath, Ontario

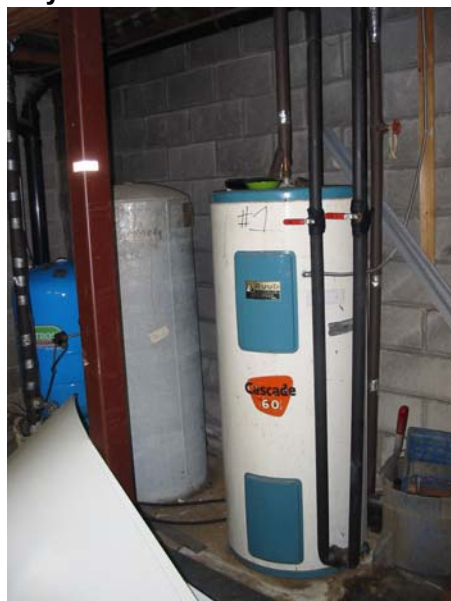
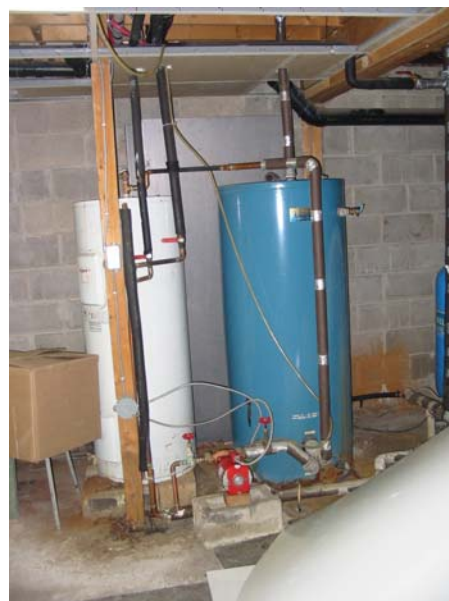
Community Hall & Locker room Domestic Water Heaters

Domestic cold water is provided via a series of wells. Domestic hot water is supplied to both the *community hall* and *locker rooms & showers* by two electric hot water heaters with water storage tanks.

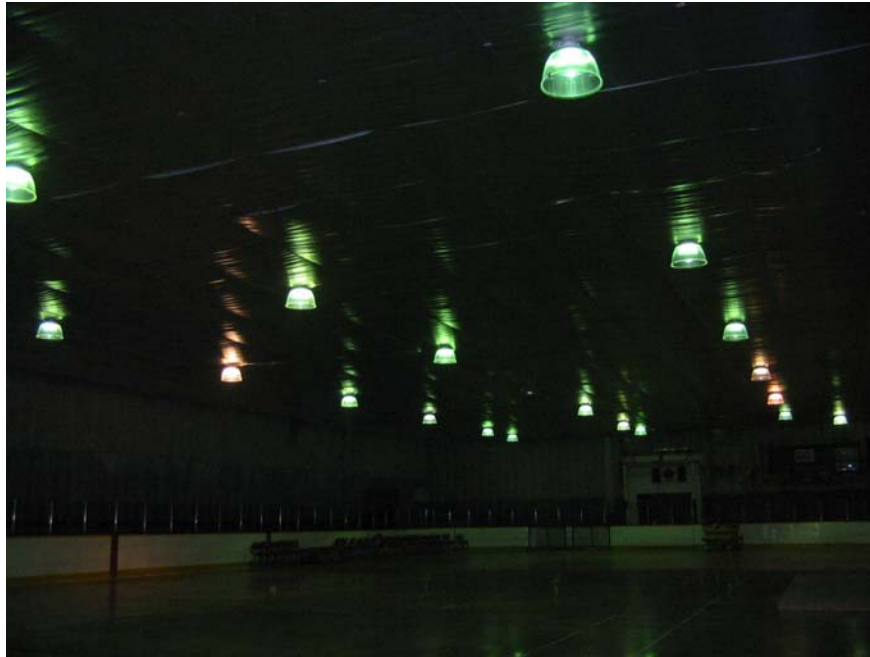
There is no heating system in the *Rink*. Ventilation is provided through a series of permanently open louvres by natural ventilation. There is no carbon monoxide or propane detection system in either the *rink* or *resurfacer room*. There is no power ventilation system in the *rink*.

The *Rink* has two inches of acoustic spray-on insulation installed above the board height and in the ceiling space above the rink only. A fair amount of this insulation has detached from the structure. There is no other thermal insulation in this space.

Since the existing building is not insulated, it is especially susceptible to temperature swings based on the ambient conditions. The current ventilation system inside the rink consist of permanently open louvres that allow for moisture migration into the rink. The combined temperature and humidity fluxuations above the rink surface allows the air to exceed it's dew point, forming fog above the ice. This has a detrimental effect on both the building and contents as it promotes corrosion and the growth of mold/mildew. This is especially of concern during the fall and spring.

A propane fired desiccant dehumidifier should be installed. This would eliminate the formation of fog inside the rink. The lower humidity levels would hinder the growth of mold/mildew & formation of corrosion. In addition to the building condition and occupant comfort improvements, the reduction in relative humidity would also reduce the run time on the chiller in the *ice plant* required to maintain ice surface temperature.

The lighting system in the Rink currently consist of suspended metal halide fixtures. Great care is taken of these fixtures to maximize their efficiency and operation, however both energy efficiency and maintenance requirements can be improved with the use of T5HO fluorescent fixtures. It should be noted that the ballast for the T5 fixtures will not be able to energize the lamps when the temperature inside the rink is below -17°C, hence careful attention should be paid to the expected temperatures within the space. The fluorescent fixtures would be approximately 30% more efficient than the metal halide units with a very even distribution of light over the entire ice surface.

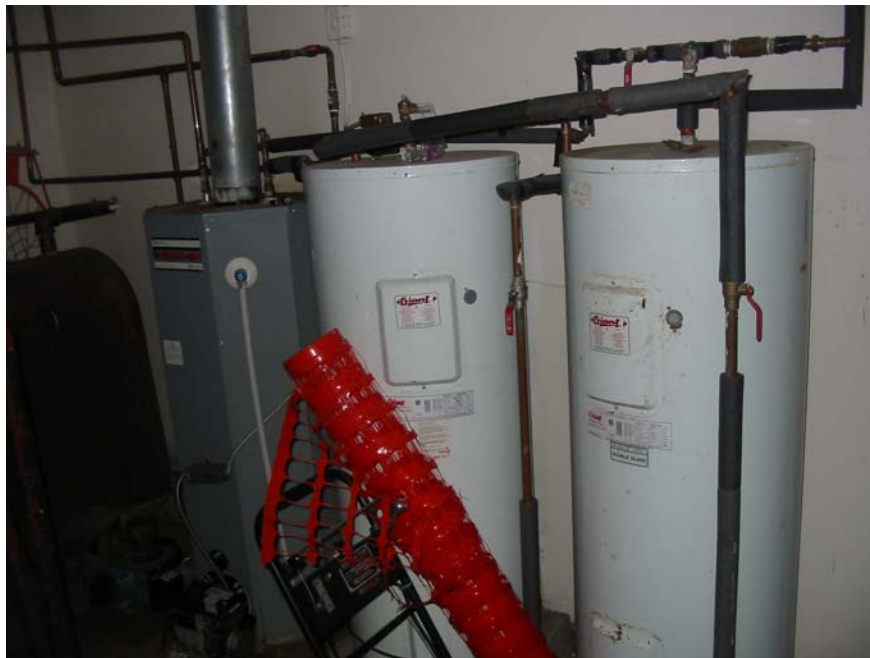
Resurfacer Room & Ice Plant Fuel Oil & Electric Water Heaters

Water is provided via a series of wells. Hot water is supplied to the ice surfacer by an interconnected system of one fuel oil hot water heater and two electric water heaters. During regular use, the electric heaters are de-energized and simply being used as insulated water storage tanks.

Currently, all the waste heat generated by the *Ice Plant* is rejected to the cooling tower. A double wall heating coil & insulated water storage tank should be installed in the *Resurfacer room*. This would allow some of the rejected heat to be captured for the preheat of the water required for the heating of the *Resurfacer* room & used in the flooding of the rink. Actual reclaim heat available capacity varies based upon the ice plant's compressor load. Even so, it is expected that this option would supply all the hot water requirements for both the ice resurfacer as well as the heating of the *Resurfacer room*. This would allow for the complete removal of the fuel oil system, with the electric hot water heaters used strictly as back-up when the refrigeration plant should require servicing.
