# **Westmeath Recreation Centre**

## **Building Condition Assessment**

**September 2011**

**Project No. 2112629A**

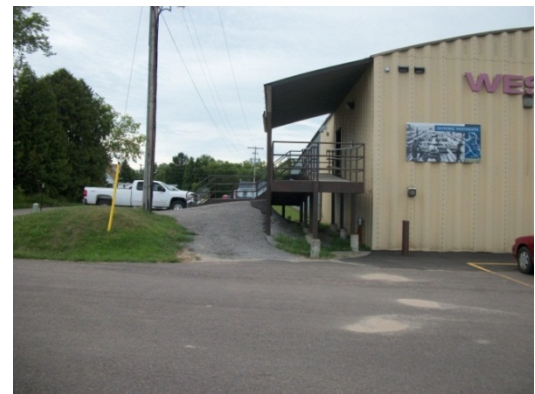
There are no defined sidewalks/walkways leading from the parking areas. The parking area along the north side leads directly to the main entrance. Access to the east handicapped entrance is provided from the adjacent road ROW with no handicapped parking available. Handicapped parking is available at the north entrance with wheelchair ramps to second floor access. As noted in item 3.4 East Side Ramp and Stair Entrance, it is recommended that the entrance ramp be replaced due to its' condition.

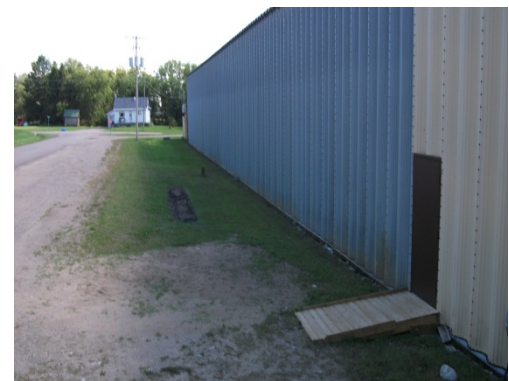
Drainage from the building is problematic on all sides with exception of recently completed north wall. The road along the east side is considerably higher than the arena floor and all ground surface drainage from the road ROW goes to a shallow ditch beside the arena which has a minimum slope. Consideration should be given to providing a more pronounced ditch grade with an in ground drainage system complete with yard drains. The drainage system would outlet to the adjacent drainage creek.

Cost Estimate: \$8,000

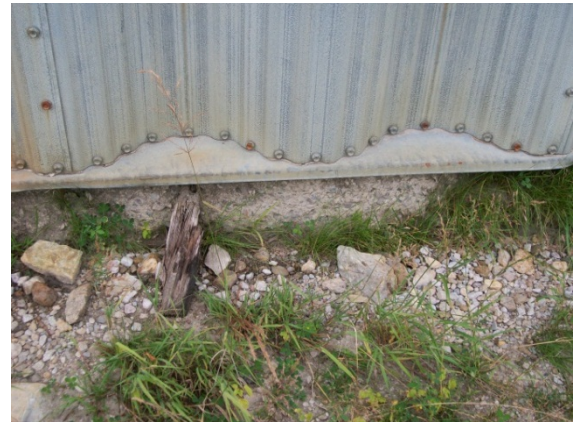
The top 8-12" of the exterior foundation walls are exposed and therefore were the only portion visually inspected. The west exterior portion of the foundation has areas of moderate to severe spalling and disintegration underneath the sill of the steel superstructure. The concrete sills under the south-west and south-east man doors also showed the same types of deterioration. The east, north, and south foundation walls are in fair condition.

Visually the foundation walls are in "fair" condition. Recommended repair involves properly cleaning the damaged areas of walls from loose debris and dirt, then application of an epoxy mortar compound over the damaged areas until flush with original thickness of wall.

Quantity Estimate: 45m<sup>2</sup>  
Unit Cost Estimate: \$200/m<sup>2</sup>  
Cost Estimate: \$10,000

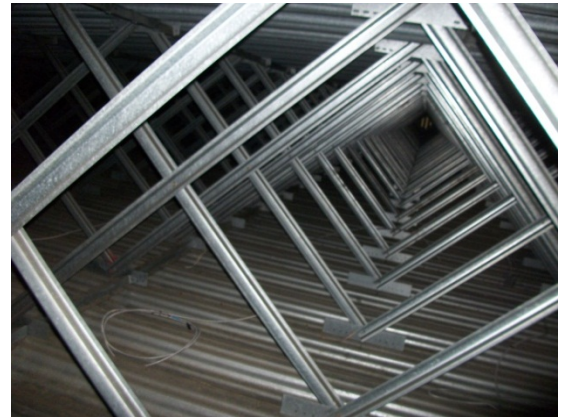
The roof structure is a Behlen corr-span. This is a heavy gauge corrugated steel roof supported by a steel truss system. The steel truss system had no signs of cracking twisting, or deflection. The galvanized coating on the truss members is in excellent condition. The corrugated steel roof has surface rust forming on the exterior surface however the rust is not currently detrimental to the strength of the structural. There are several areas at the seams of the metal roofing where leakage may be occurring due to gaps in the connection points.

Visually the roof structure is in “Good” condition. Recommended repair involves the application of a bituminous membrane to ensure seams and connection points do not leak onto the interior components of the structure.

Cost Estimate: \$60,000

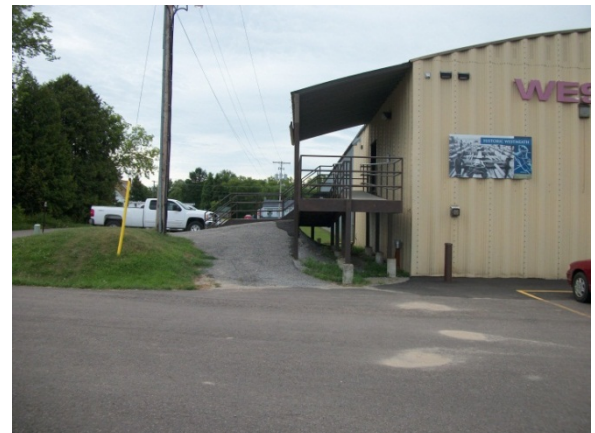
The structure on the east side of the building is constructed of steel framing and a concrete deck for a ramp. The entire underside of the frame for the ramp is covered with moderate to severe corrosion. The steelwork under the stairs appears to have been patched on multiple occasions. The galvanized grating is in good condition and may be salvaged if possible.

The steel frame for the stairs and ramp are in “poor” condition. Recommended repair involves a complete replacement of the entrance structure with either a galvanized steel or concrete structure.

Cost Estimate: \$40,000

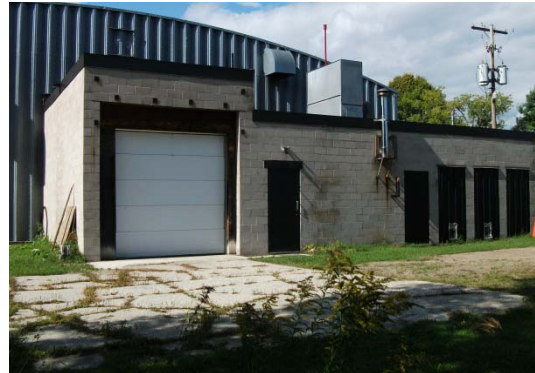
The concrete block structure which houses the Zamboni and ice plant is in good condition. Repairs are required to localized cracks as well as sealing between the concrete block structure and the arena metal siding.

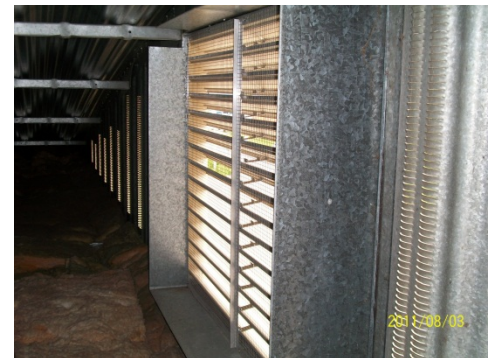
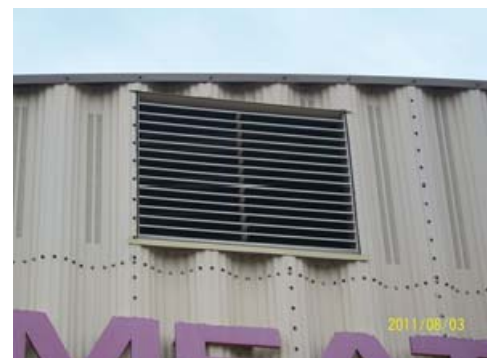
The present condition of the gable vents and motorized fan is poor. Recommended repair involves replacement of the existing vents with a weatherproof type complete with thermostatic control dampers and sealing existing slotted siding.

Cost Estimate: \$6,000

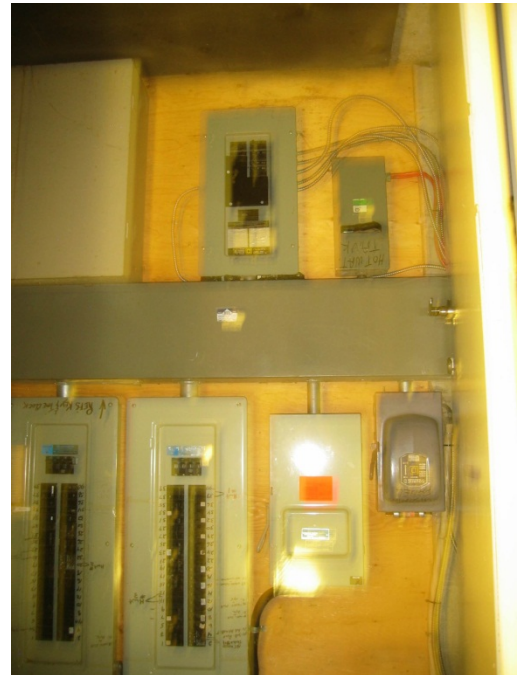
The building service entrance consists of a main disconnect, meter cabinet and splitter with the splitter feeding sub-panels and equipment disconnects (see photograph). The equipment appears to be original to the building and remains serviceable. Due to its' age, and potential degradation of plastic components such as insulators and loosening of connections, annual thermographic inspection of the system is recommended.

Visually, the equipment is in "average" physical condition. Although the equipment should last the life of the building, as it ages, 5% of the total cost should be budgeted for upgrades and repairs every 5 years.

Main Electrical Service Entrance  
Gear showing Some Distribution  
Gear.

Quantity Estimate: 1 system  
Unit Cost Estimate: \$5,000  
Cost Estimate: \$20,000

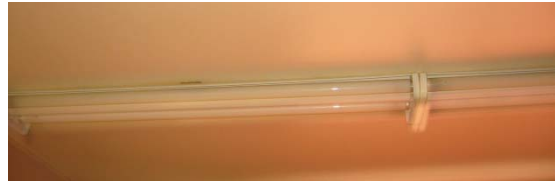
Generally the lighting throughout the hall, washrooms, change rooms etc. are T12 or T8 type fluorescent fixtures. Most fixtures are older, with some of the lenses beginning to crack or deform or missing. As noted in the Energy Audit Report (2008), the T12 fixtures should be replaced with T8 or T5 fixtures.

Typical T12 light fixture

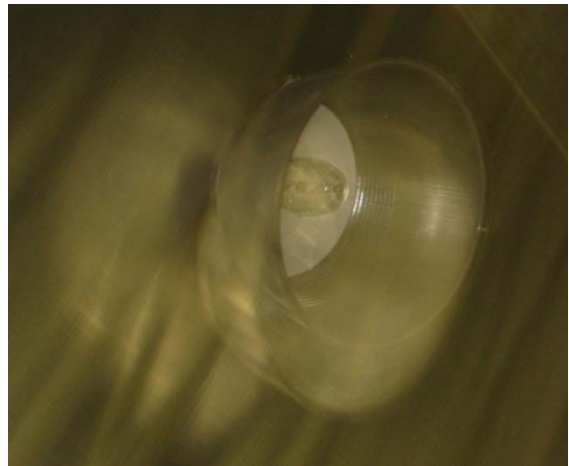
The rink lighting is with metal halide fixtures and should be replaced with T5HO fixtures as recommended in the Energy Audit Report (2008). The T5HO bulbs can last over ten years before needing to be replaced due to loss of brightness or color shift. T5HO can only be used if the rink is heated to above minus 17 Celsius.

Typical Rink Light Fixture

Cost Estimate: \$27,000

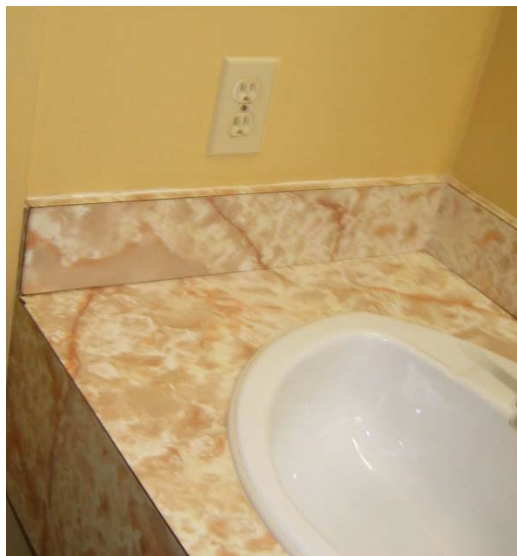
Unsafe Outlet Installation

Cost of Relocation: \$500

Required immediately

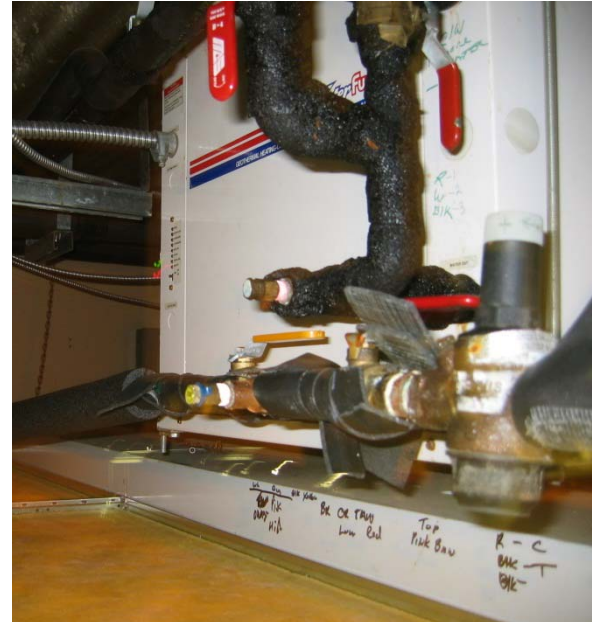
Access to the Water Furnace through the “Bar” is very limited. As a minimum, the door swing into the mechanical room should be changed to permit a service technician a means of escape in case of accident. Consideration should be given to providing access from the men’s washroom, to avoid passing through the “Bar”.

Water Furnace Heat Pump In  
Kitchen Ceiling Space

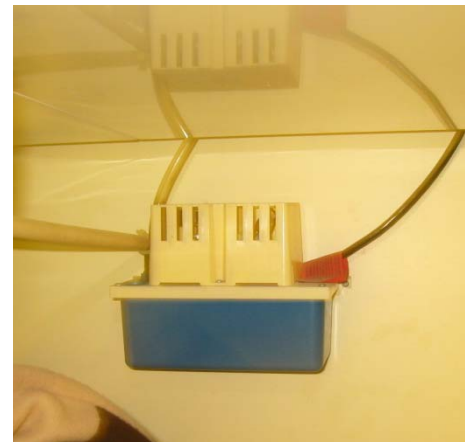
The condensate from the heat pump and HRV located beside the stairs is removed by a small condensate pump. To avoid flooding damage, an alarm connected to the building security system is recommended.

Condensate Pump serving  
WaterFurnace and Heat Recovery  
Unit

Cost Estimate: \$4,000

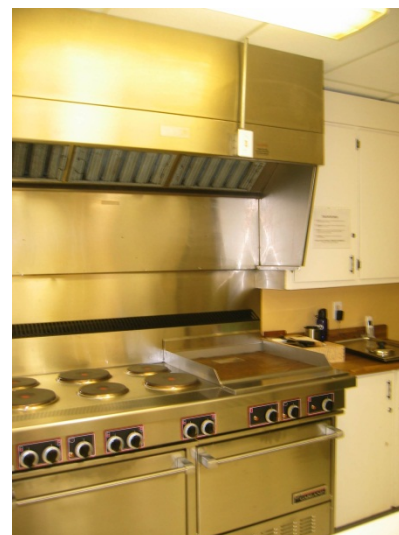
The commercial range has a commercial exhaust hood above the range, with a switch to control the fan mounted on the unit face. A hood of this type should have an exhaust flow rate of approximately 150 to 250 cfm per linear foot of length, or in the range of 1000 to 1500 cfm. With the fan running, very little air could be felt moving through the baffles, or it is unlikely that the hood is extracting cooking fumes as required. For the hood to function properly, a source of make-up air is required. Cost of such an installation for Type II system (no deep frying) will be approximately \$20,000 or for a Type I system (deep fryers with fire suppression system, etc.) approximately \$50,000. Either system will require approximately \$5,000 to \$6,000 in Engineering fees for design of system.

Exhaust Hood and Range (Partial)

Cost Estimate: \$60,000 for kitchen exhaust hood  
(Type II)  
\$25,000 for canteen exhaust hood  
(Type I)

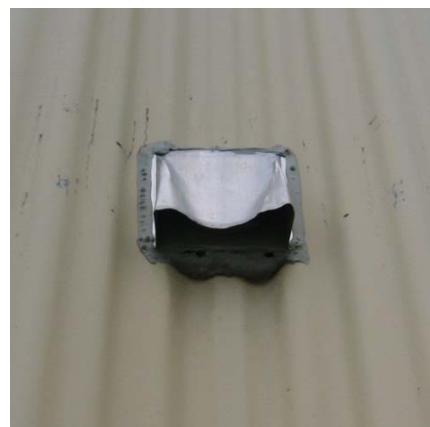
The washrooms are heated by electric baseboard and ventilation is provided by small residential style exhaust fans. The exhaust fans did not turn on when the lights were on and therefore did not appear to be functional. The exhaust hoods for these fans are bent, preventing the dampers from fully opening and should be repaired. Cause of the fans not working should be identified and repaired. Life expectancy of a small exhaust fan is approximately 5 to 10 years depending on use. Replacement cost of the small fans is approximately \$250

Typical Damaged Exhaust Hood

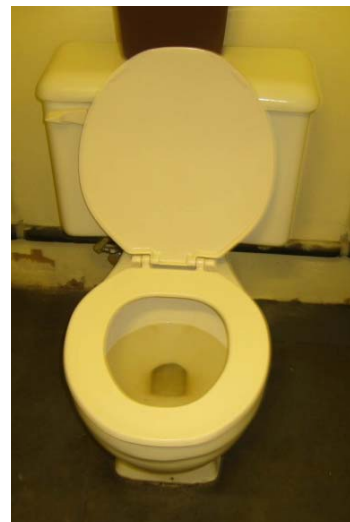
The 13 L per flush round bowl style water closets (toilets) are no longer permitted by code for public use; however, the porcelain is durable, in good condition and the water closets are still functional. Only one water closet was found leaking water through the flap valve, hence whole scale replacement is not recommended. Should a water closet break or crack, a current elongated bowl water closet with open front seat as required by code is recommended. Minimum flush capacity of 500 gms using 6 L of water as per the Veritec or Toronto test program is recommended. Approximately half of the water closets required holding the handle down to complete the flushing action and should be repaired to ensure a complete flush even if user leaves the stall. The cost of repairing or replacing the a flap valve or adjusting a chain is mostly labour and about half an hour per water closet and as a result, no cost has been provided.

Typical Older Water Closet

Unit Cost Estimate:	\$1,000
Cost Estimate:	\$12,000

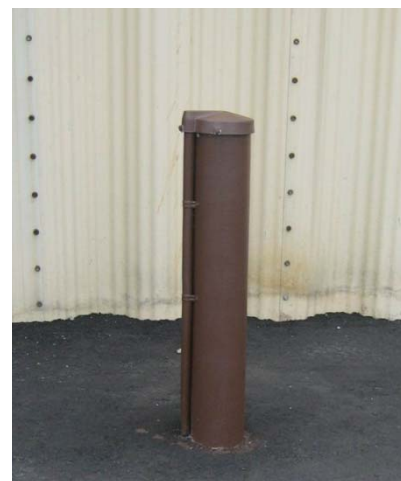
Current regulation requires that well head be a minimum of 18 inches above the surrounding ground and be graded to drain away from the well head. None of the wells meet this requirement and need re-grading. As noted under Site Works, lot grading needs work to solve the drainage issues.

Drinking Water Well head, with asphalt sloping past well casing
