# **Westmeath Recreation Centre**

## **Building Condition Assessment**

**September 2011**

**Project No. 2112629A**

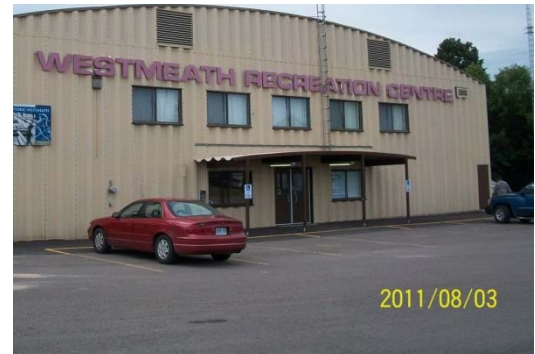
There is minimal asphalt parking along the north side of the building for handicap and general public. Additional parking is provided along the adjacent streets and across the road at the municipal ball field. The paved area in front of the main entrance was replaced in 2010 and has a life expectancy of 20 years.

Although parking adjacent to the arena is minimal, parking on the adjacent street ROW is not a concern.

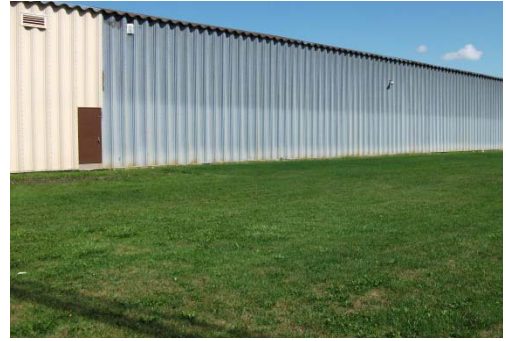
A new drainage tile was installed in 2010 along the west building foundation/footing which has reduced the amount of subsoil water adjacent to the foundation wall. This drain tile outlets to the adjacent drainage creek.

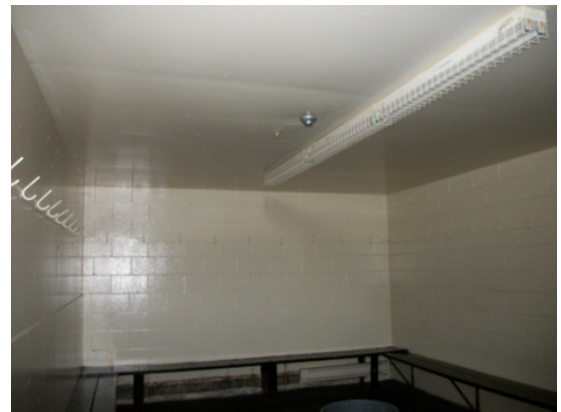
The block walls are in "good" condition and there are no recommendations for repair.

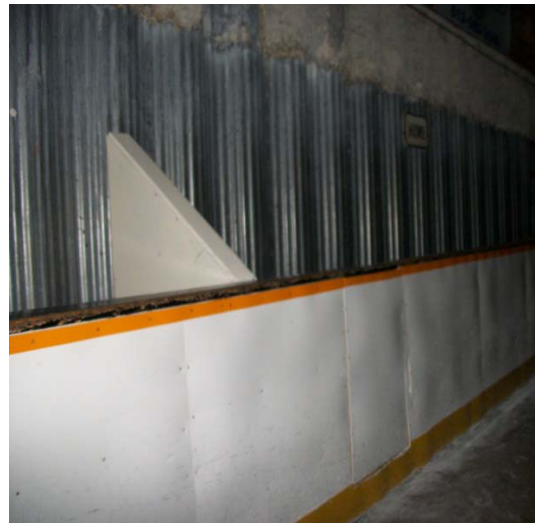
The concrete rink slab showed no signs of major movement or any irregular cracking. Recent repairs along the outside edge of the slab where the boards are located were detected.

Visually the rink slab is in “Good” condition. No recommendations for repair.

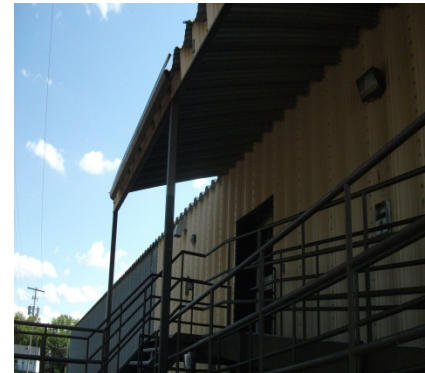
The building does not have eaves troughs and downspouts except that there is approximately a 16'-0" length at the second floor entrance on the east side of the building. This section of eave trough has caused problems over the years with ice damming and runoff discharge. Consideration should be given to modifying the roof slope to provide drainage to both sides of the entrance stairs/ramp allowing for a safer entrance.

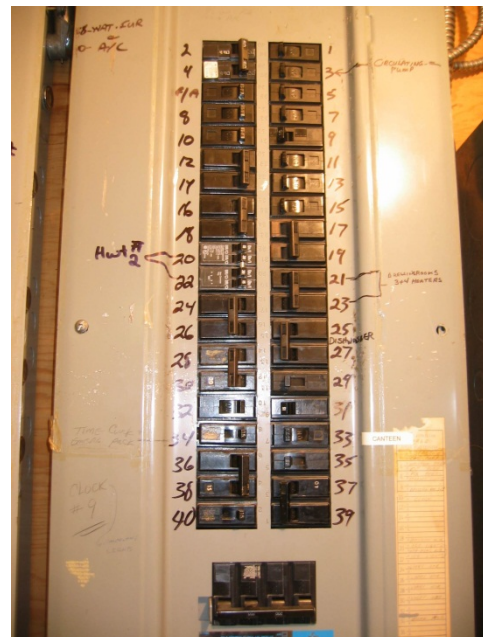
The distribution system consists of several breaker panels, motor starters and disconnects located at the main service entrance and throughout the facility. Visually, the equipment is poor to average condition with plates bolted over opening left when removing breakers, and marking on covers to indicate circuit use. The equipment is a mix of original and newer equipment with differing life expectancies. Breakers will need to be replaced as they age or wear out and as replacement parts become difficult to obtain, may require replacement of complete panels. The cost of these replacement breakers and panels is included in Section 5.1 Distribution Systems Service Entrance.

Typical breaker panel.

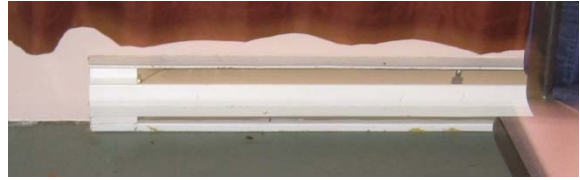
Typical Baseboard Heater

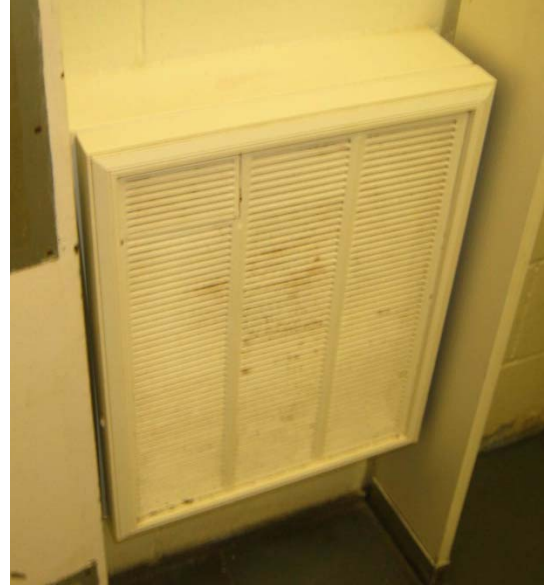
Typical Wall Unit Heater

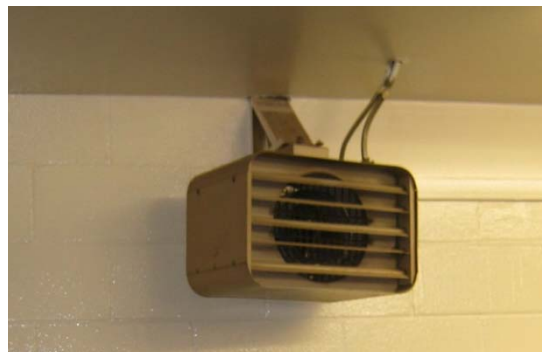
Typical Industrial Heater

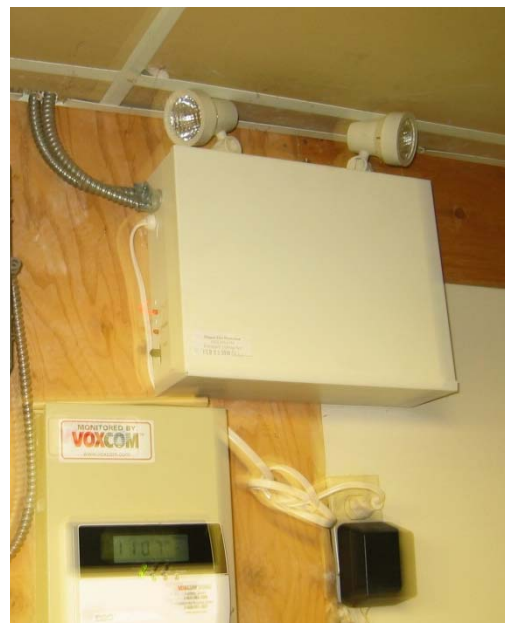
Typical Emergency Light with Battery Pack

Units should be inspected, tested and maintained in conformance with CAN/CSA-C282, "Emergency Electrical Power Supply for Buildings." These tests include visual, operational, and duration on a monthly, semi-annual and annual basis. A log book is available from CSA for recording these tests.

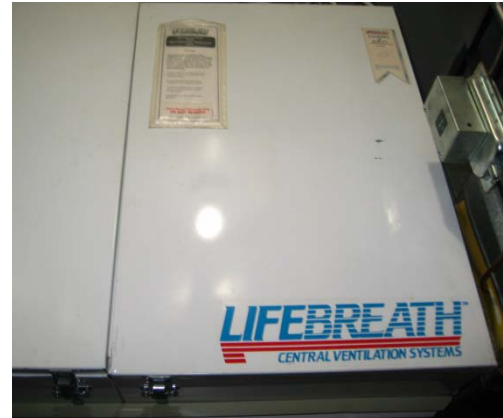
The outdoor air for the community hall is provided by two LifeBreath HRV units. Top-up heat for the supply air to the hall is provided by electric heaters. Life expectancy for these units is 20 to 25 years. Regular changing of filters to avoid clogging of heat exchanger is recommended.

Typical Heat Recovery Unit

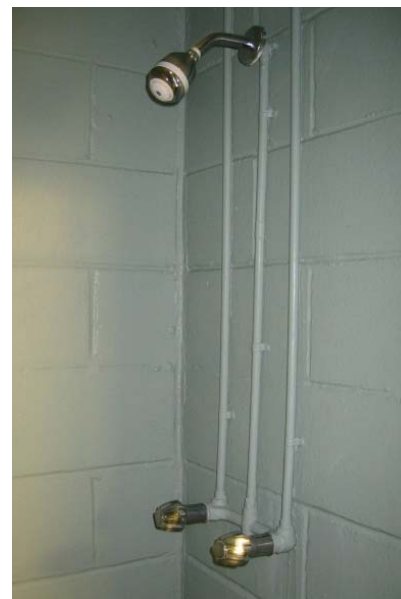
Typical Shower

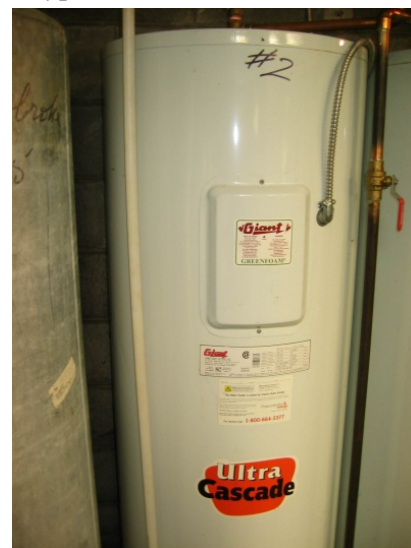
Typical Hot Water Heater
